# Manhole Inspection Summary

Manhole # S29YY1003MH

**Location** Address: **5200 AMBERLY WAY**

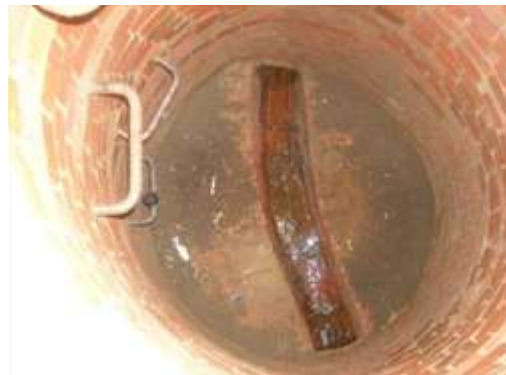
Top View

Evidence of surcharge - Bench debris.

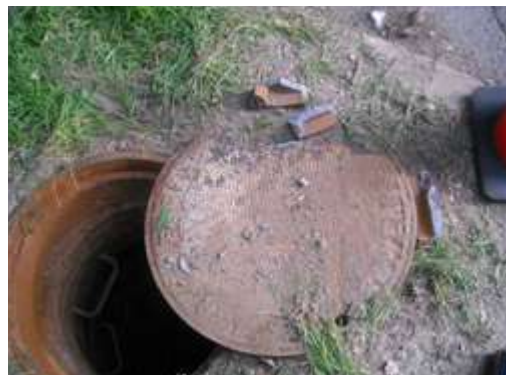
Broken lid

We broke the lid to gain access.

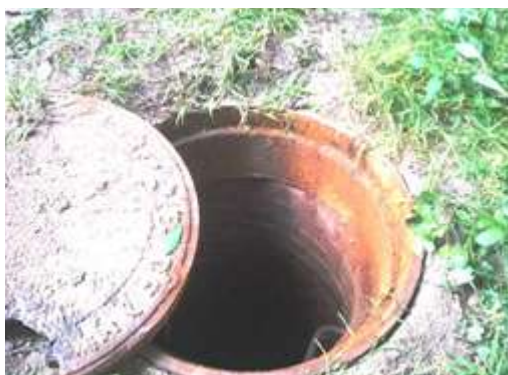
Defect

Frame leaks. Corbel and Barrel infiltration.

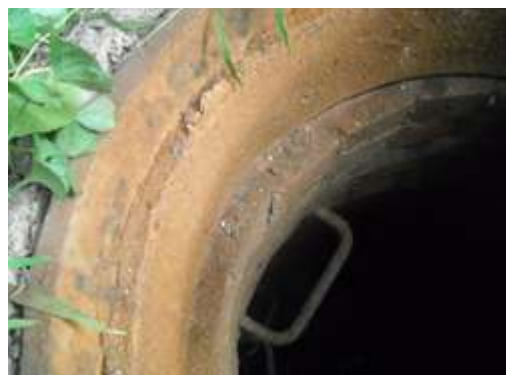
Defect

Frame leaks. Frame offset. Corbel infiltration.

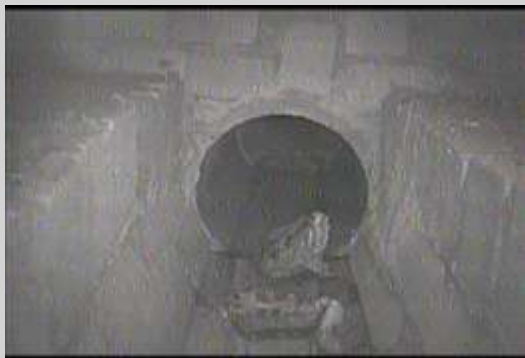
### 8 in. Circular Gravity Sewer Pipe In @ 5 O'Clock

Deposits: ☐ None ☐ Mud ☐ Sludge ☒ **Debris** ☐ Grease

Silt Depth: **0** (in.) Deposits Extent: **Light**
